THE BELLTOWER

1ST PRESBYTERIAN CHURCH OF KANKAKEE

The Saga of The Lord's Supper Window

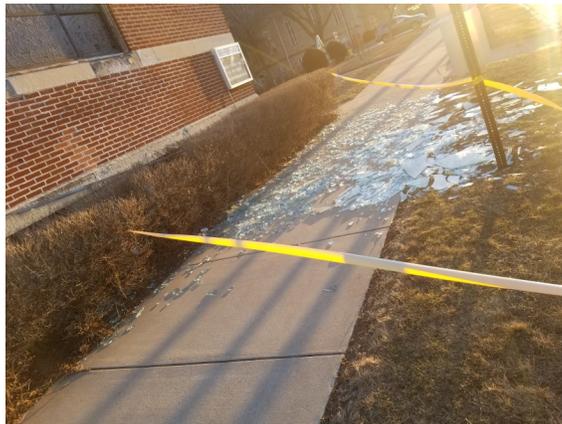
Fast forward to February 28th, 2019. A wind storm with gusts up to 70 mph hit Kankakee. Some of the wood had rotted around the Last Supper window and caulking had dried

holding the outer plate glass covering. This allowed wind to get in between the two windows and the imbalance in pressure blew out the entire outer glass covering including the frame. Before repairs could be made, two independent contractors came and inspected the stained glass window (SGW). They both came to the same conclusion. The SGW also was pulled out in a large area of the middle of the window. The force of the wind was enough to break solder point's attaching the rebar to the SGW.

This created a danger to the structural integrity of the window itself. Without repair it would only be a matter of time before the window would completely fail. In other words fall apart. To protect it from further wind damage, the window was boarded up.

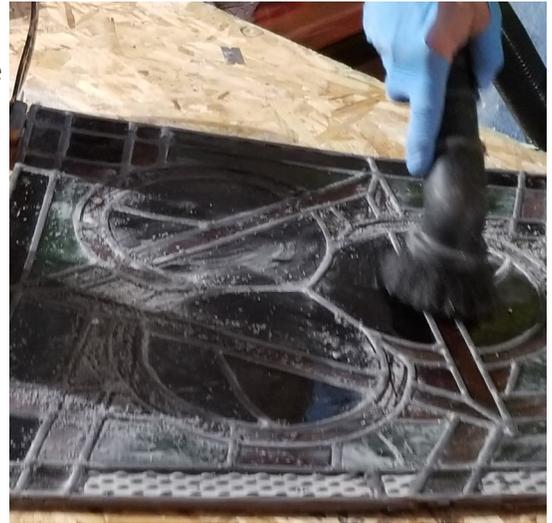
The work we had agreed on was a partial restoration or slurry restoration. Once a panel was removed, it was set on a workbench. First any loose and leeching cement intended to maintain the structural integrity of the window is removed, it is a very tedious task. The cement was originally forced in and around the lead channel holding the glass tightly in place. Then a picking tool is used to remove any loose cement from the channels—the pieces of lead and zinc in between each piece of glass are called a “came.” Once that is completed it is vacuumed and then slurry, (looks like gray goo), is spread all over the panel. It is rubbed in, filling any cracks or voids in the original cement. The slurry is forced into the lead came channels using a small brush. The addition of the new cement rejuvenates the existing cement in

the lead came channel making a stronger more waterproof window. After this slurry cement is as applied and given time to dry, the windows are thoroughly cleaned using a white powdery substance called whiting or calcium carbonate. The whiting effectively soaks up an leftover cement and polishes the glass.

Part of the process was also to inspect the rebar that connects to points on the panels. There were many instances where there was no longer a connection. The workers carefully re-soldered those points to ensure the structural integrity of the window.

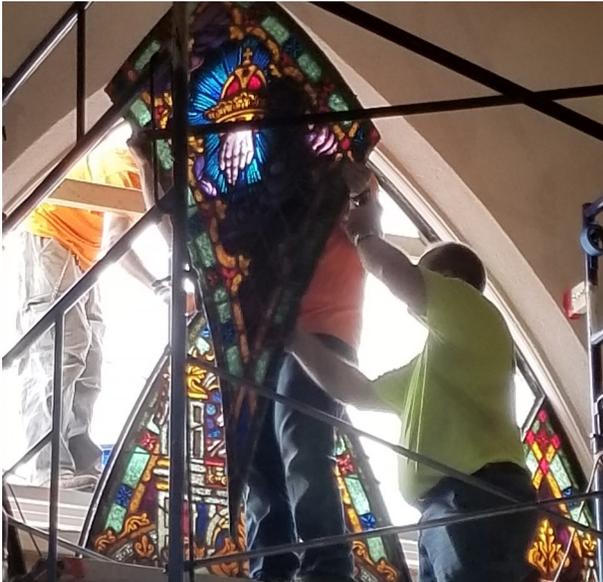
Workers carefully remove a panel from the top of the window

The outside plywood was removed only in the areas they were working. To disassemble the window the work began from the top down. There are 13 panels altogether. Workers on both the inside and outside carefully removed old caulk and materials from the panel they were working on. This was not an easy task. It could take up to an hour or more for just one panel depending on the size of the panels. It takes just the right mix of force and delicacy. Too much force and pieces of glass will start breaking.

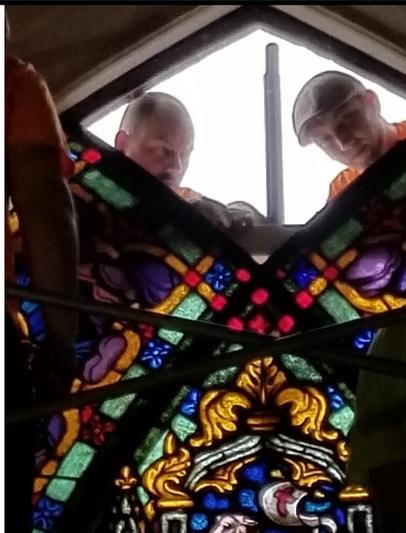
On the left two workmen work on removing old caulking from the outside of the window.

On the right it took 3 men to get this large panel down. You can only see the hands of the man in the middle

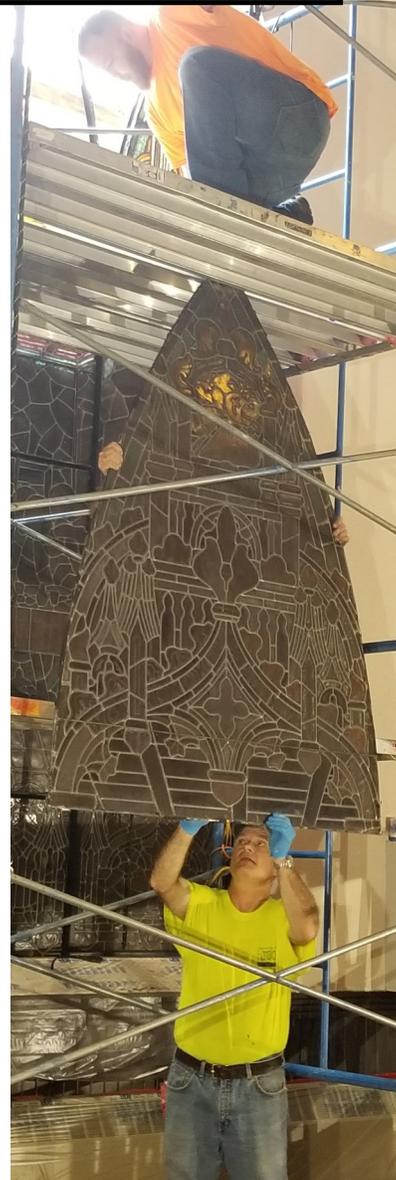
Above—After a couple of days all 13 panels were removed.
